IMPORTANT FIELD SAFETY NOTICE

CentriMag™ Acute Circulatory Support System Motor Model: 201-10002
Compatible with CentriMag™ Pump and PediVas™ Pump

September 5, 2018

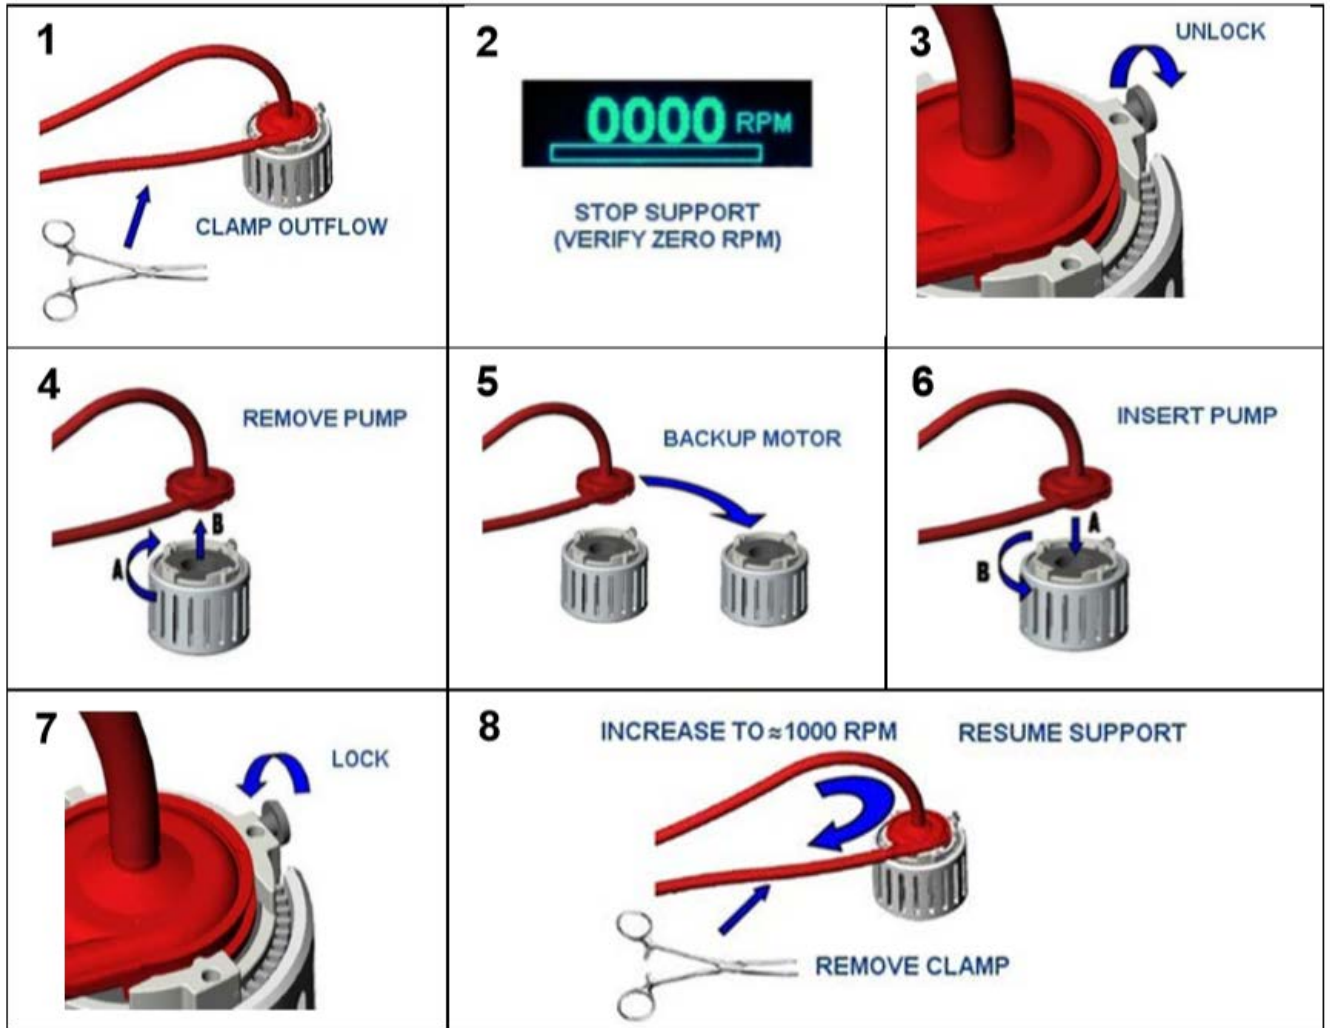
Appendix 2: Existing Blood Pump Exchange Instructions

- Graphic regarding cable handling in the relevant CentriMag Circulatory Support System Operating Manual demonstrating the proper steps from transitioning a pump between the primary and backup systems.

- A full backup system must be in the immediate vicinity of every patient supported by the CentriMag System.
- Exchange the pump to the backup system as described in the CentriMag System Operating Manual and in Appendix 2. Improperly exchanging the motor to a backup console only could cause damage.
- Inspection of the CentriMag Motor, including the cable, for damage should be conducted prior to use. Do not use if damaged. If the cable is damaged and not visible as part of the inspection, the console will alarm during the procedure. Further detail about the visual inspection can be found in Appendix 3.

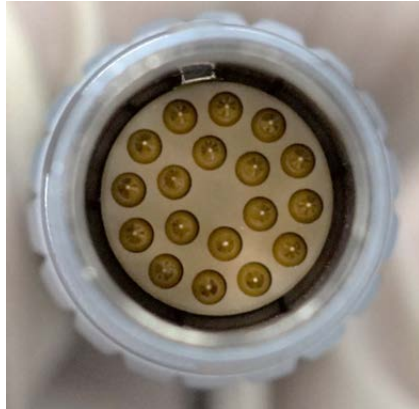
Figure 2: Motor Connector Pin View

- Visual inspection regarding inspection for motor cable damage from the CentriMag Circulatory Support System Operating Manual and supplemental pages (for 1st Generation Consoles)
1. Visually inspect the CentriMag Motor connector for bent or broken pins. Check for burn marks or melted plastic.

Note: If there are any issues while connecting the CentriMag Motor to the CentriMag Console, inspect the Motor port on the rear of the Console for damage, particularly for any broken pins that may be lodged inside.
