## URGENT FIELD SAFETY NOTICE

**Name of product affected:** Biplex vascular grafts and Biplex BioValsalva Conduits (stentless and stented)

**FSCA identifier:** CAPA 167

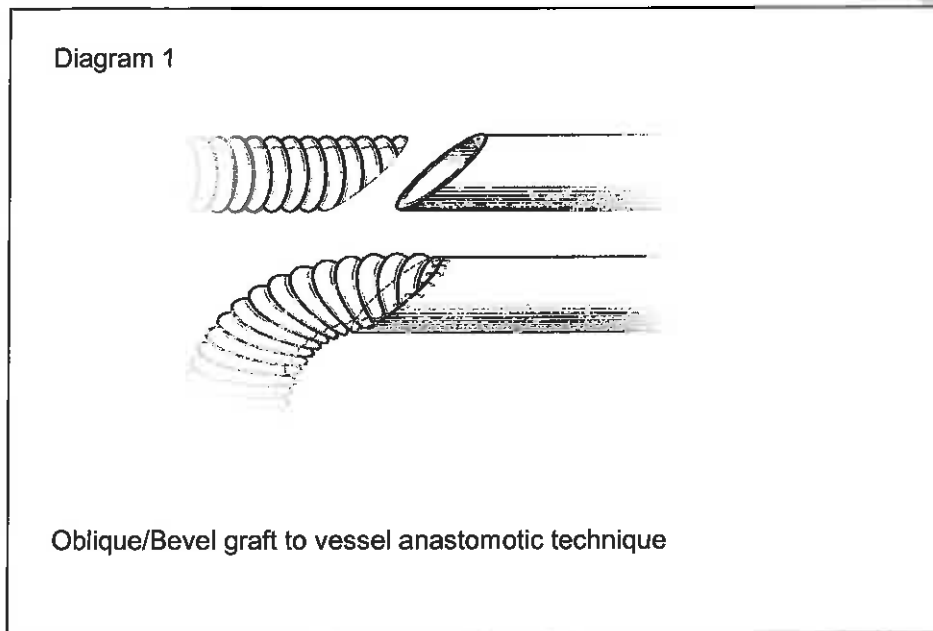
1. It is essential that the sutures are tightened each time they are passed through the material.
2. In order to achieve a smooth suture line and good haemostasis, it is important that the graft diameter selected must not be oversized relative to the distal anastomotic site.
3. Care should be taken not to apply excessive tension at the distal anastomosis by ensuring the graft is cut to the correct length.
4. The use of haemostatic agents/ accelerants and/or felt/ pledgets may reduce the incidence of suture line bleeding and resternotomy.
5. The use of an oblique/ bevel graft to vessel anastomosis is recommended. This technique will minimise any blood leakage arising from the oversizing of the graft relative to the native vessel (see Diagram 1)
