Zimmer Spine 7375 Bush Lake Road

URGENT MEDICAL DEVICE CORRECTION AND REMOVAL

Subject: PathFinder NXT Fixed Rod Holder Instruments

Affected Products: PathFinder NXT Fixed Rod Holder Instruments Part numbers 3573-1 (angle handle) and 3573-2 (straight handle); All lots.

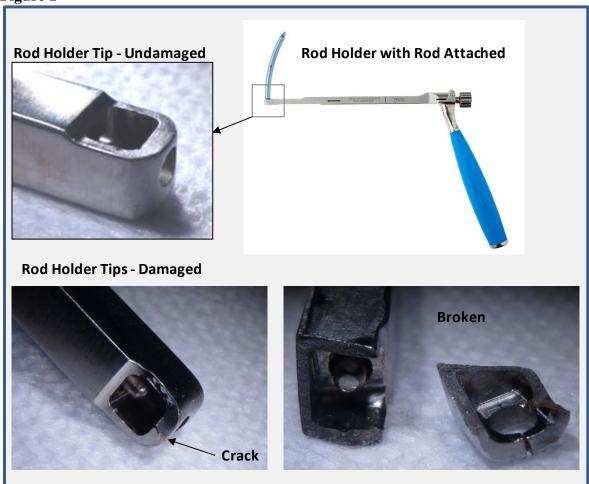
Zimmer Spine, Inc. (Zimmer) is initiating a voluntary correction and removal of PathFinder NXT rod holders because Zimmer has received complaints that the tip of the rod holder may crack or break when the rod is manipulated during surgery.

<u>Step</u>	Current IFU and Surgical Technique Guidance	Additional Guidance / Information to Reduce Rod Holder Tip Damage			
PRIOR TO PROCEDURE	Inspect instrument for damage If damage or wear is noted that may compromise proper function, do not use	See Figure 1 for example of crack that may lead to breakage			
ROD PLACEMENT	Turn set screw knob until it seats fully on the percutaneous rod	The rod is fully seated when the knob is finger tight	If damage to the rod holder tip is found		
CLOSURE TOPS PLACEMENT	N/A	When inserting closure tops, ensure that the extender sleeves and rod holder are not touching/wedging together and creating a lever effect on the distal end of the rod holder	before or during use, Fixed Grip 5.5mm Rod Holder (part number 3562-1) may be utilized with a mini open technique		
ROD HOLDER REMOVAL	Disengage the rod from the rod holder by rotating the knob counterclockwise until stopped Translate the rod holder away from the construct and remove from the incision	The knob should be fully loosened prior to removal Translate the distal tip away from the rod/screw construct Do not rock the holder excessively to disengage from the rod

POST USE	N/A	Inspect the rod holder tip for damage after each use. See Figure 1			
		If damaged, remove from service

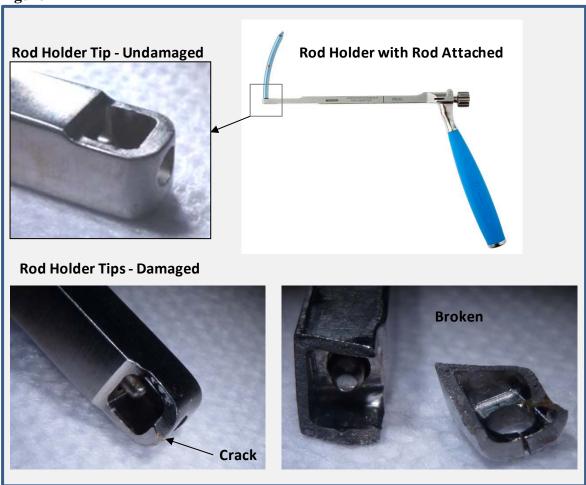
Zimmer Spine, Inc. (Zimmer) is initiating a voluntary correction and removal of PathFinder NXT rod holders because Zimmer has received complaints that the tip of the rod holder may crack or break when the rod is manipulated during surgery.

<u>Step</u>	Current IFU and Surgical Technique Guidance	Additional Guidance / Information to Reduce Rod Holder Tip Damage			
PRIOR TO PROCEDURE	Inspect instrument for damage If damage or wear is noted that may compromise proper function, do not use	See Figure 1 for example of crack that may lead to breakage			
ROD PLACEMENT	Turn set screw knob until it seats fully on the percutaneous rod	The rod is fully seated when the knob is finger tight	If damage to the rod holder tip is found before or		
CLOSURE TOPS PLACEMENT	N/A	When inserting closure tops, ensure that the extender sleeves and rod holder are not touching/wedging together and creating a lever effect on the distal end of the rod holder	during use, Fixed Grip 5.5mm Rod Holder (part number 3562-1) may be utilized with a mini open technique		
ROD HOLDER REMOVAL	Disengage the rod from the rod holder by rotating the knob counterclockwise until stopped Translate the rod holder away from the construct and remove from the incision	The knob should be fully loosened prior to removal Translate the distal tip away from the rod/screw construct Do not rock the holder excessively to disengage from the rod

POST USE	N/A	Inspect the rod holder tip for damage after each use. See Figure 1 If damaged, remove from service
