URGENT FIELD SAFETY NOTICE

Leica M525 F50 Surgical Microscope

FSCA-Identifier: CAPA-2012-04-003-H

Review of Illumination Failure Back-up Procedure in User
Manual – Effective Immediately

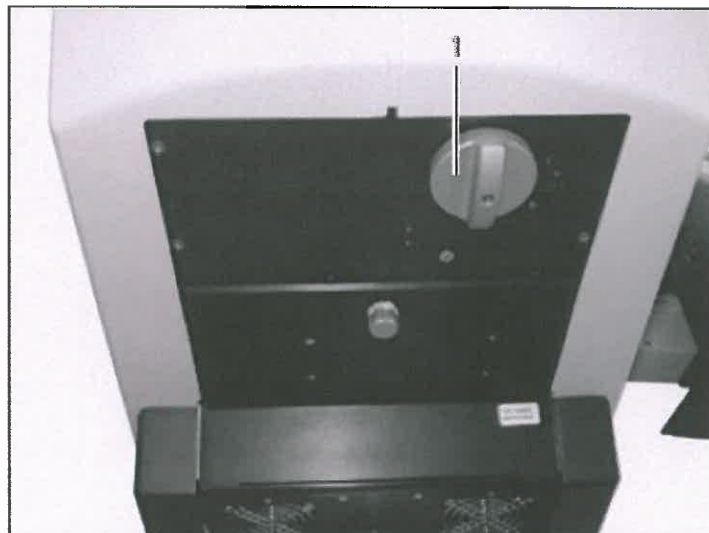
Switch manually to auxiliary illumination.

Failure of the illumination can be dangerous for the patient!

→ If the main illuminator fails, switch to the auxiliary illuminator immediately.

→ Turn the rotary knob (1) from Position 1 to Position 2.
The illumination is switched to the auxiliary illuminator.

Replace the defective main illuminator at the next opportunity, then switch back to the main illuminator.

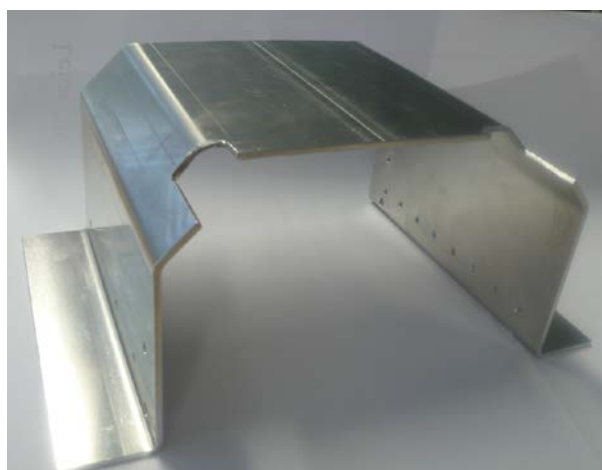
Cooling sheet metal:

Weight: 600g
Mass: 180mm x 270mm x 115mm
Material: Aluminum

- A Leica Microsystems representative will be contacting your facility to make the necessary arrangements to install metal cooling sheet on the xenon power supplies of your Leica M525 F50 Surgical Microscope.
