Technical Update

Product: ABL90 FLEX

Scope: Release of Software V2.8

Ref.: TU0092

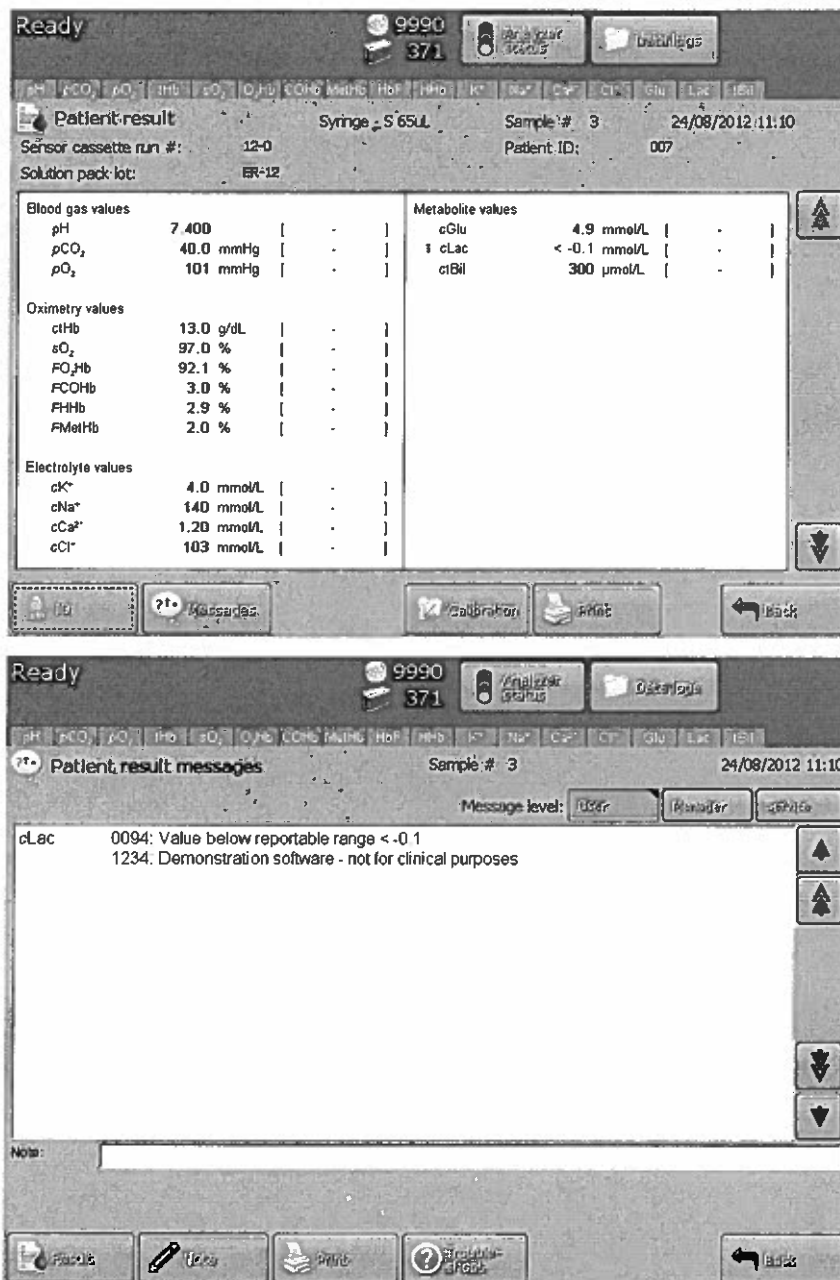
See example below where the measured Lactate is below the reportable range of -0.1 mmol/L.

By default this is not enabled, but by adding the following to the ROMA.INI file, this will be enabled:

ShowValuesOutOfReportableRange=1

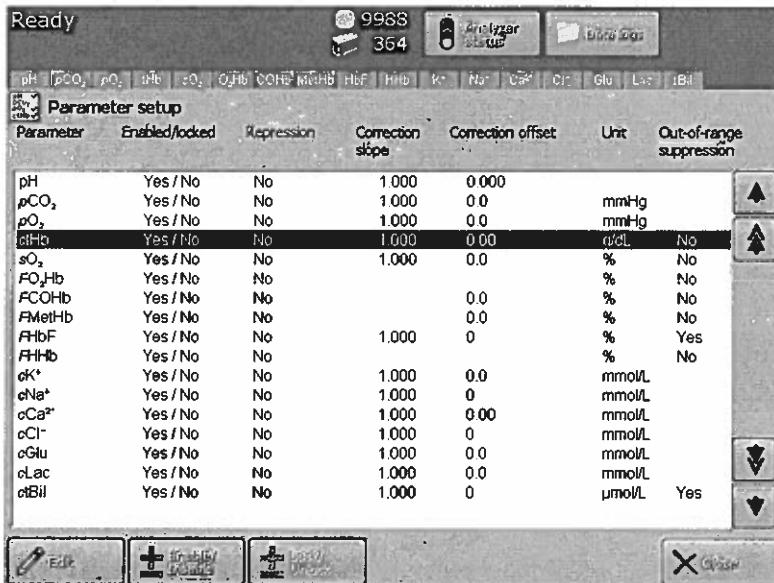
It is now possible to adjust both offset and slope for the tHb, previous versions only allowed correction of the slope. See example below.

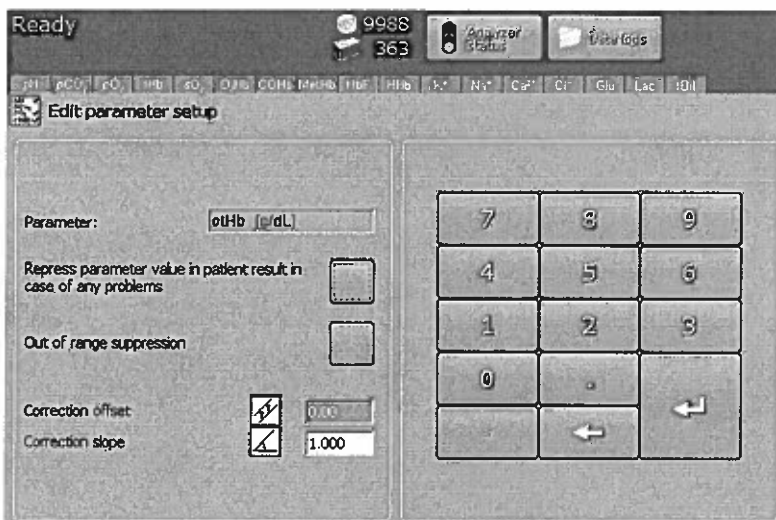
Please note that how much the offset can be changed is limited to +/- 2 mmol/L.

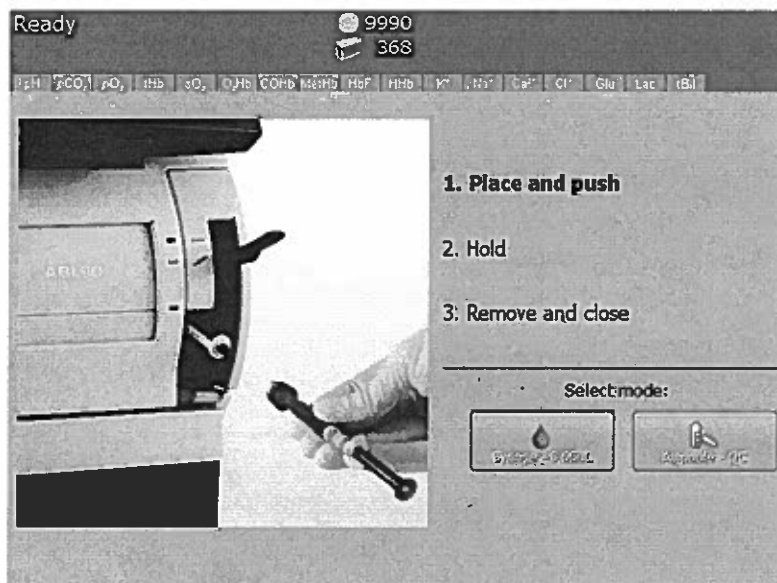
The sample process has also been updated with a three step process and video, in order to better guide the operator through the sample aspiration process.
