URGENT FIELD SAFETY NOTICE

**Edwards Lifesciences LLC
Ascendra 2 Delivery System – Loader Assembly
Model Numbers 9320AS23 and 9320AS26**

Ref: AT-GEN-0000039

January 07, 2011

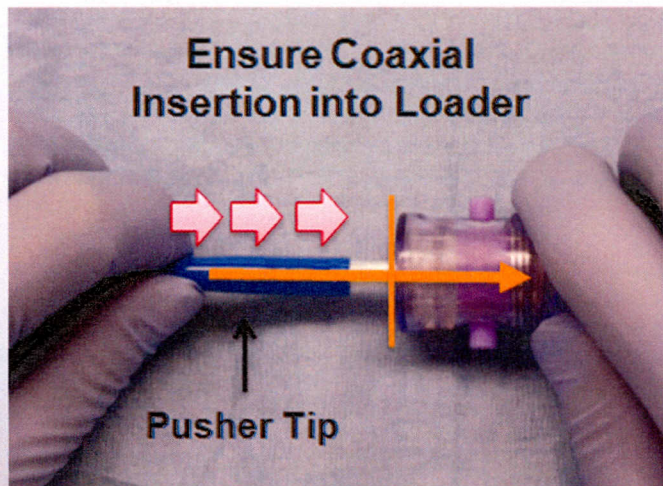
Do not insert the delivery system into the loader at an angle

1. When inserting the Ascendra 2 delivery system into the proximal end of the loader, ensure that the delivery system is coaxial with the loader. Do not insert the delivery system into the loader at an angle.

Hold the delivery system at the pusher tip while slowly pushing the delivery system into the loader coaxially and with short movements

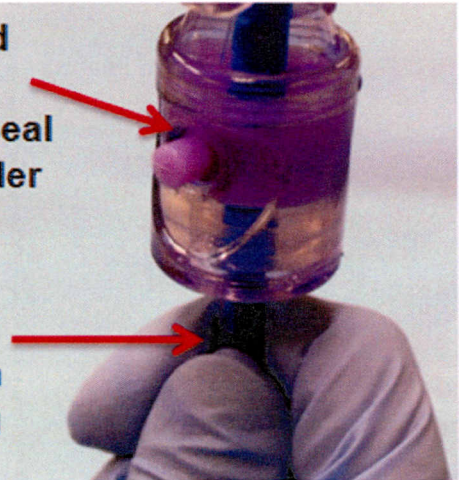
If fluid appears to be leaking from the button valves, press both button valves a few times to re-align the button valve seal to the loader and **reflush** again according to the steps above.

- Following the instructions for use, flush the loader from the distal hub of the delivery system. If the button valves on the loader have become partially dislodged, fluid will be seen leaking from around one or both of the button valves. If this happens press both button valves several times to reseat the seal and then repeat the flushing procedure as per the instructions for use.
