Urgent: Field Safety Notice / 004-12

Product name: IH-Com kit Fullversion (Data Management and Result Interpretation Software)
Product REF: 009000
Software versions: 03.0.43 / 03.0.52 / 03.0.59

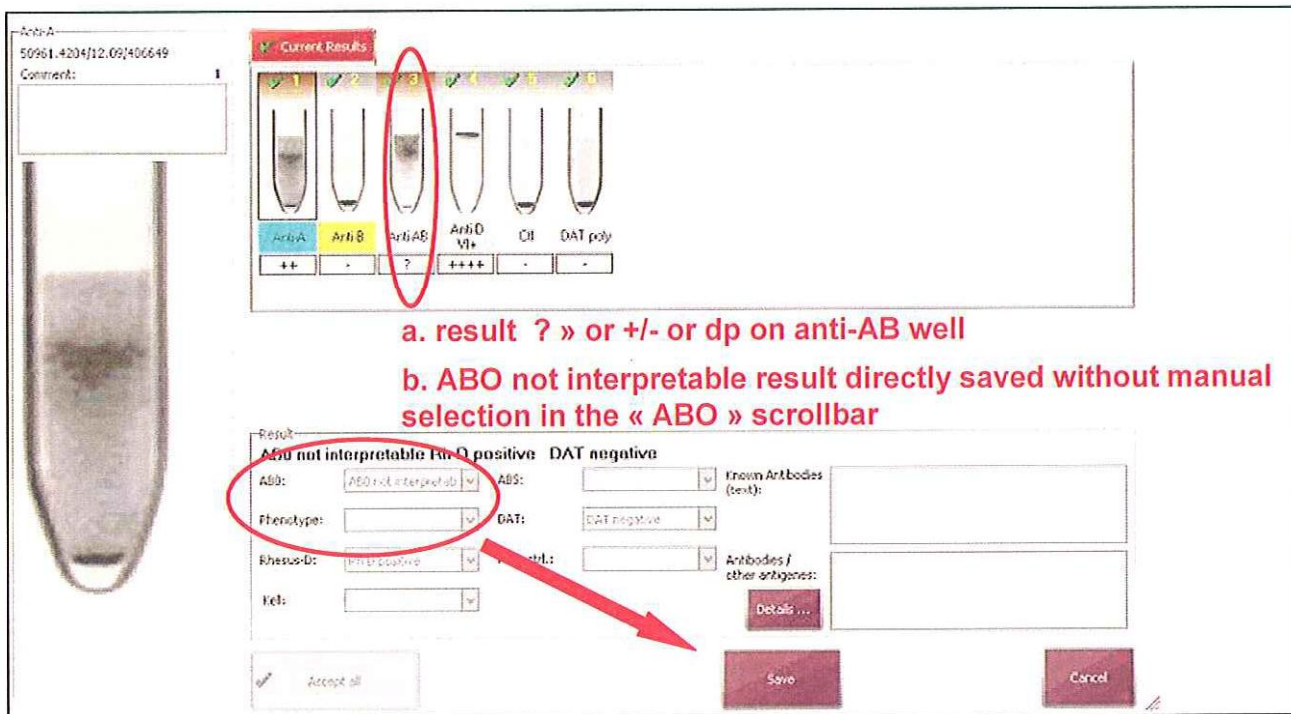
Illustration of IH-Com -"Second reading" option

1. IH-Com Software is connected to the laboratory Host through ASTM* communication mode and,
2. an "ABO not interpretable" result is obtained due to a reaction "?" or "+/-" or "dp" in the anti-AB well of an ID-Card** intended for ABO forward grouping (see point a. on the illustration on p.2) and,
3. the "Second reading" option is deactivated and IH-Com results are directly sent to the Host,

3'. the "Second reading" option is activated but the "not interpretable" result obtained in IH-Com is directly saved and sent to the Host without a manual selection by the user in the ABO scrollbar (see point b. on the illustration on p.2)
