URGENT: Medical Device Field Corrective Action

Re: OLYMPUS THUNDERBEAT Electrosurgical Unit Hand Instruments

PROCEDURAL TIPS AND TECHNIQUES FOR THUNDERBEAT

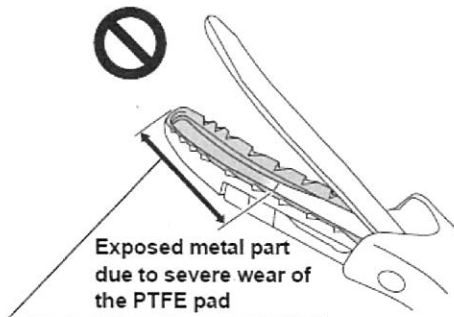
Figure 1

PTFE pad: Deformation, split, protruding, severe wear (Figure 1), and partial separation (Figure 2), resulting in falling off into the body cavity

- The probe tip and grasping section of the THUNDERBEAT instrument may experience normal wear due to ultrasonic vibrations. Care should be taken to avoid activation of ultrasonic energy (Seal & Cut mode) when tissue is not present in the grasping section. The probe tip and/or the PTFE pad may be damaged. If any visual damage is confirmed on the PTFE pad and/or the probe tip, replace the THUNDERBEAT instrument.

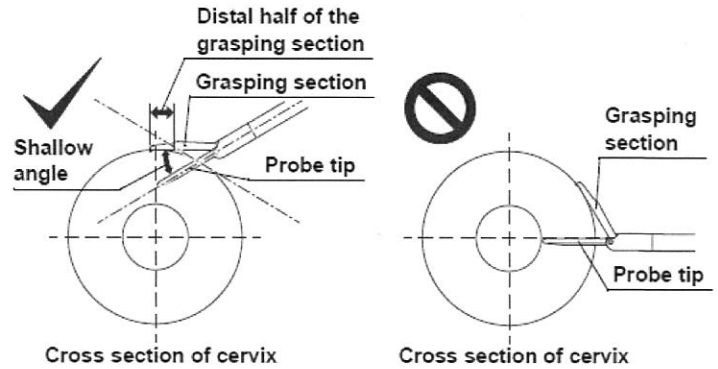
Figure 4

Narrowly open the grasping section and use the probe tip to drill in laterally at a shallow angle while activating the Seal & Cut mode. Close the grasping section slowly and cut through tissue using the distal half of the grasping section to achieve a slow cut and shallow bites around the cervix. (Figure 4)
