## Urgent Medical Device Correction – 2955842-10/21/2013-010-C

Replacement of “Metal-finish” Lamp Modules on the da Vinci® Si™ (IS3000) System Illuminator

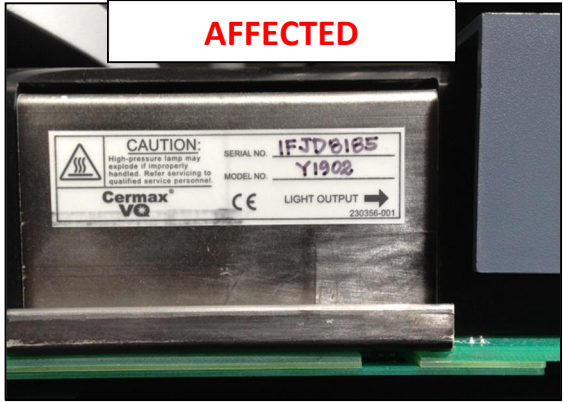
<p>Lamp module with a <b>metal finish</b></p>

<p>control board, leading to a red Preventive Maintenance Advisory (PMA) that shows up on all monitors and cannot be dismissed by the user. This PMA is detected during the required pre-operative power on and set-up procedures. There is the rare occurrence that a -05 version metal-finish lamp module can damage an illuminator in such a way as to prevent the illuminator from communicating with lamp modules. This damage does not prevent the illuminator from properly controlling the light output of the lamp module; however, the damage is detected by the <i>da Vinci</i> Si Surgical System and the message “Illuminator lamp module error: Please reseal or replace lamp module” is displayed on both the patient side monitor and the surgeon console. This error does not affect the lighting of lamp module in the normal fashion, and there are no reports of lamp failure that have been associated with this issue.</p> <p>2. There is a potential that, in very rare instances, the lamp module may not illuminate. This is a theoretical failure mode only in that there are no reports of lamp failure that have been associated with this issue. If this failure to illuminate were to occur, it would be detected upon system set-up prior to surgery.</p>

<p>Remove the installed metal-finish lamp module and install a plastic-finish lamp module. If you need to order the plastic-finish replacement lamp module, go to Step 2.</p>
	<p style="text-align: center;"><b>Plastic finish</b></p>
