Cressier, November 05, 2014

**Urgent: Field Safety Notice / 003-14**

**Product name:** IH-1000  
**Product REF:** 001000  
**IH-1000 software version:** all versions

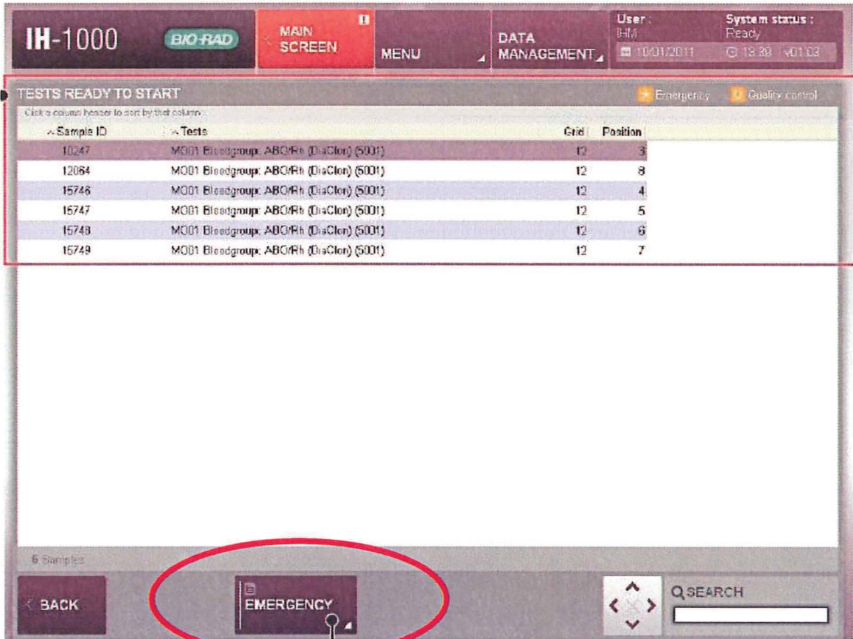
**This information only concerns the use of the “Emergency button”.**

Further to a customer complaint, we have confirmed that in the specific conditions described below, the IH-1000 software may lose the link sample/"test in progress". This loss might in the worst case lead to a mismatch between the test result and the sample.

Our in depth investigation has determined this issue is linked to the sample management when using the "emergency button" and might occur **ONLY** in the following conditions:

1. A Not Urgent rack (green label) is inserted with more than one sample AND;
2. **ALL** the samples on this rack are manually selected as "Emergency" by clicking on the "Emergency button";  
Then once the first emergency sample is processed, the instrument ejects the rack before all processing is completed.
3. If a rack is then reloaded with new samples in the exact same positions and reinserted in the same slot, the link sample/"test in progress" is lost.

This issue will be permanently corrected in the next IH-1000 software version. This version will be released by the end of Q1 2015.

In the meantime, customers should immediately discontinue using the "emergency button" and should process **ALL** emergency samples exclusively on the urgent rack (red label).
