URGENT – Field Safety Notice Philips M1783A and M5526A Sync Cables Electrical Interference Could Pose a Risk for Patients

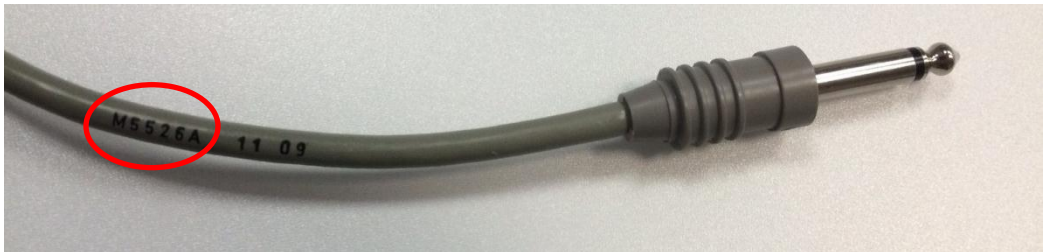
<p>AFFECTED PRODUCTS</p>	<p>Product: Philips Sync Cables, models M1783A and M5526A</p> <p>Units Affected: All Philips sync cables, models M1783A and M5526A, are affected.</p>
<p>PROBLEM DESCRIPTION</p>	<p>When a Philips monitor/defibrillator is receiving an ECG signal from an auxiliary bedside monitor via a sync cable, the following can occur if the monitor/defibrillator experiences interference from electrical fast transients (EFTs) while connected to AC power:</p> <ul style="list-style-type: none"> • On the HeartStart MRx and HeartStart XL, EFT noise can be misinterpreted as an R-wave • On the HeartStart XL+, EFT noise can disable ECG monitoring, and potentially interrupt demand mode pacing*. <p>*Note: It is contrary to the instructions in the XL+ Instructions for Use (IFU) to perform demand mode pacing while using the sync cable to provide the ECG signal from a bedside monitor. The XL+ IFU includes the following warning: “When pacing in Demand Mode, the ECG cable from the patient must be directly connected to the HeartStart XL+.” If the user follows this warning, this problem cannot occur on the XL+.</p>

<p>HAZARD INVOLVED</p>	<p>When using a sync cable with the HeartStart MRx or HeartStart XL, EFT noise can be mistaken as an R-wave. If this occurs when performing synchronized cardioversion, there is a potential for inducing ventricular fibrillation if shocks are synchronized to EFT noise instead of the patient’s actual R-wave.</p> <p>When using a sync cable with the HeartStart XL+, EFT noise can disable ECG monitoring, and potentially interrupt demand mode pacing, leading to a possible delay in therapy. A power cycle is required to resume ECG monitoring. (Note: fixed mode pacing is not impacted by this issue.)</p>
<p>HOW TO IDENTIFY AFFECTED PRODUCTS</p>	<p>Philips M1783A and M5526A sync cables identified above are affected by this issue.</p> <p>The model number is printed on the outside of the cable, near the end with the ¼” phone plug, as shown below:</p>

Philips will replace affected sync cables with a new cable free of charge. A Philips Healthcare representative will contact you to make arrangements for this replacement. We appreciate your patience as we work to schedule your replacement.

ACTION TO BE TAKEN BY CUSTOMER / USER	<p>Prior to receiving a replacement sync cable, you can continue to use affected sync cables, provided that they are only used to connect the ECG Out jack on the monitor/defibrillator to the ECG (input) port on a bedside monitor. The issues described in this letter do not impact this application of the sync cable.</p> <p>Affected sync cables should not be used to connect the ECG Out jack of a bedside monitor to the ECG (input) port on the monitor/defibrillator.</p>
ACTIONS PLANNED BY PHILIPS	<p>Philips will replace all affected sync cables with a new sync cable free of charge. A Philips Healthcare representative will contact customers with affected devices to arrange for your replacement.</p>
FURTHER INFORMATION AND SUPPORT	<p>If you need any further information or support concerning this issue, please contact your local Philips representative: <Philips representative contact details to be completed by the KM / country></p>
