URGENT-FIELD SAFETY NOTICE
2015-03-09

Subject: Suction module (Auxiliary O₂ & Suction module) sometimes can't be activated

Document title
Hardware Update Auxiliary O₂ and Suction Unit

UPDATE INSTRUCTIONS MCC/15/001/IU

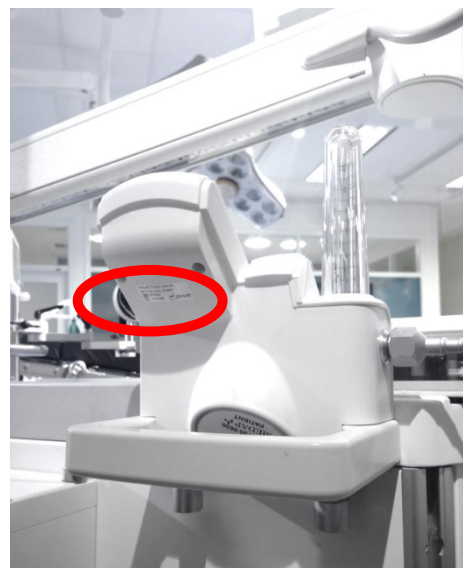
A MAQUET serial number label is attached on the backside of the module.
