URGENT - Medical Device Correction Philips HeartStart MRx Defibrillator/Monitor RFU Indicator shows undocumented pattern

<p>AFFECTED PRODUCTS</p>	<p>Product: Philips HeartStart MRx Defibrillator/Monitor</p> <p>Units Affected: MRx unit types with software versions F.03.06 (M3535A) and T.00.05 (M3536A) and earlier and the following part numbers:</p>

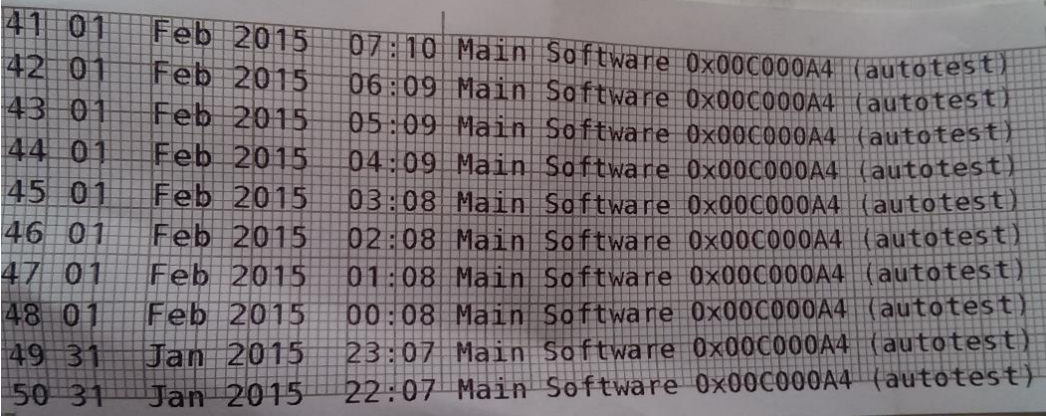
<p>If this pattern appears and the device is turned on, it will revert the RFU back to an hourglass, indication that it is fully functional in all monitoring and therapy modes. There is no clinical risk if the device that has displayed this RFU pattern is turned on and put into service.</p> <p>A device experiencing this issue will continue to run automated RFU test hourly and report a 0x00C000A4 code in the Status Log summary (pictured below) each time:</p>

<p>Note that while an MRx experiencing this issue will reliably report this code in the Status Log, existence of the C000A4 code in the Status Log does not necessarily mean that the device is experiencing this issue.</p>
<p>HAZARD INVOLVED</p>	<p>If the issue were to occur the user may unnecessarily remove the MRx from service. However, the performance of the device in use is unaffected by this issue.</p>
<p>HOW TO IDENTIFY AFFECTED PRODUCTS</p>	<p>Philips HeartStart MRx Defibrillator/Monitors identified in the Affected Products section above are affected by this issue.</p> <p>The part number of the HeartStart MRx Defibrillator/Monitor is printed on the primary label on the bottom of the MRx</p>
