URGENT - Field Safety Notice Juno DRF

Additional safety label for table base

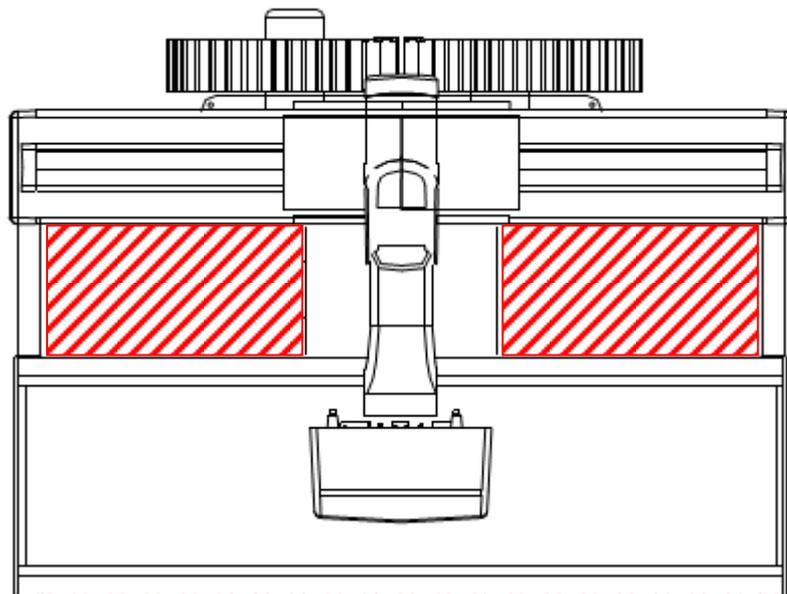
In the areas highlighted in the following picture the **risk of squeezing** is present between the detector carrier structure and the tabletop supporting arms in case the motorized movements are activated.

It is forbidden to enter or stay in such areas when the system is powered on.
