URGENT - Field Safety Notice *Philips DuraDiagnost X-ray system*

Audible Exposure Termination Beep May Not be Audible

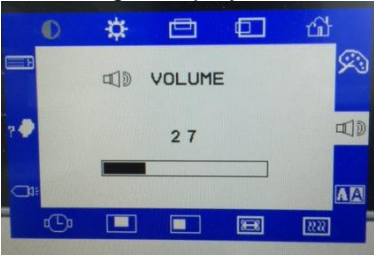
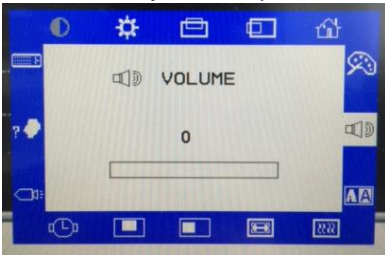
AFFECTED PRODUCTS	DuraDiagnost X-ray systems
PROBLEM DESCRIPTION	<p>DuraDiagnost systems provide an audible exposure termination signal (Beep) through the speaker integrated into the monitor. However, buttons or keys on the monitor allow the user to turn the volume setting down to "0", in which case the beep will not be heard at the conclusion of an exposure. Note that the current volume setting is displayed when the buttons or keys are depressed.</p> <div style="display: flex; justify-content: space-around;">

</div>
HAZARD INVOLVED	<p>If the monitor volume is set to "0", the absence of an audible exposure termination signal may lead the operator to assume that an exposure was not performed correctly, and therefore to unnecessarily repeat the patient exposure.</p>
HOW TO IDENTIFY AFFECTED PRODUCTS	<p>The DuraDiagnost systems with Monitor Model Numbers as "451220108521" and "459800968541" are affected, which can be found in the label on the back of Monitor:</p> <p style="text-align: center;">Example:</p>

ACTION TO BE TAKEN BY CUSTOMER / USER	<p>If the exposure termination signal (beep) from the monitor speaker is not audible, use the buttons or keys on the monitor as described in the Problem Description section above to verify that the volume is not set to "0" and change the volume setting if it is.</p> <p>Should users feel uncertain regarding this action, please contact your local Philips representative and reference FCO71200155.</p>

ACTIONS PLANNED BY PHILIPS	Philips will supply the FCO71200155 as field action to address above issues free of charge. A Philips Service Engineer will contact you when the Field Action Kit is available to be implemented.
FURTHER INFORMATION AND SUPPORT	If you need any further information or support concerning this issue, please contact your local Philips representative. Please reference FCO71200155 when contacting your local Philips representative.
