**URGENT DEVICE
CORRECTION**

Problem Description Baxter Healthcare Corporation *(to be adapted locally)* is issuing a device correction for specific models of the Artis dialysis systems in order to update the current software versions to new software versions. The current version allows for the possibility of resetting and continuing patient treatment without following the instructions for addressing Alarm #642, "Arterial Chamber: Level Adjustment Required." This will subsequently deactivate the alarm for the remaining treatment time. The new software versions prevent the possibility of continuing the treatment without following the instructions for addressing Alarm #642, as written in the Operator's Manual.

Product Family: Artis

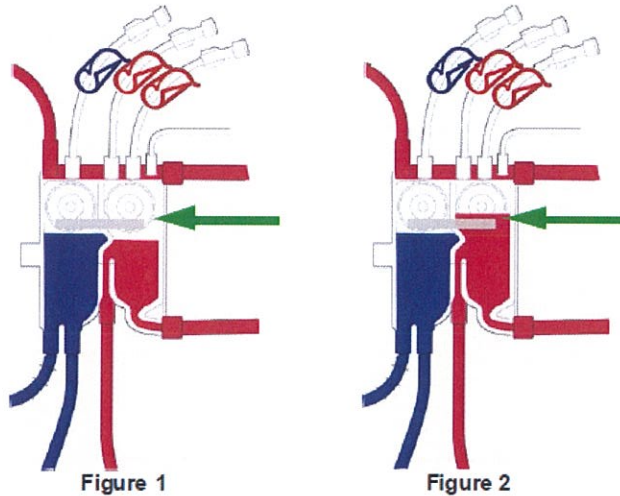
When the "Arterial Chamber: Level Adjustment Required (#642)" alarm occurs, check the blood level in the Arterial chamber while the Arterial pump is still stopped.

- If the blood level is below the frosted line, as shown in Figure 1, proceed with alarm troubleshooting to adjust the Arterial chamber level. Incorrect blood level may result in microbubbles smaller than 20 μL reaching the patient increasing the risk of air embolism.
- If the blood level is above the frosted line, as shown in Figure 2, grease the Pressure Transducers at the end of the treatment as described in the "13.13 Cassette Panel O-Rings Inspection and Greasing" section of the Operator's Manual. Improper greasing of Pressure Transducers may result in wrong arterial pressure measurements caused by ineffective Pressure Transducer and cassette coupling.

Actions taken by Baxter to avoid reoccurrence of the issue Baxter has developed new software versions for specific models of the Artis dialysis system. Baxter service representatives will begin contacting customer facilities in April 2017 in order to upgrade software versions. Until a new software version is installed on Artis machines, clinicians may continue to safely use the affected Artis dialysis systems, following instructions that are provided in the Current Operator's manual to address Alarm #642:

1. Clinicians may continue to safely use the affected Artis dialysis systems while utilizing additional vigilance to adhere to the instruction for use for addressing Alarm #642, as documented in the Operator's Manual until the software correction can be provided to your facility by Baxter at no charge.
2. A local Baxter service representative will contact your facility to schedule the upgrade
3. Complete the enclosed customer reply form, and return it to Baxter by either faxing it to (*insert local contact information*) or scanning and e-mailing it to (*insert local contact information*) or sending it by post to (*insert local contact information*). Returning the customer reply form promptly will confirm your receipt of this notification and prevent you from receiving repeat notices.
