## Product Correction

**Date Issued** December 8, 2017

Product Name	List Number	UDI
ARCHITECT c4000 Cuvette Segment	02P75-01	Not applicable
ARCHITECT c8000 Cuvette Segment	01G46-01	Not applicable
ARCHITECT c16000 Cuvette Segment	09D32-05	Not applicable

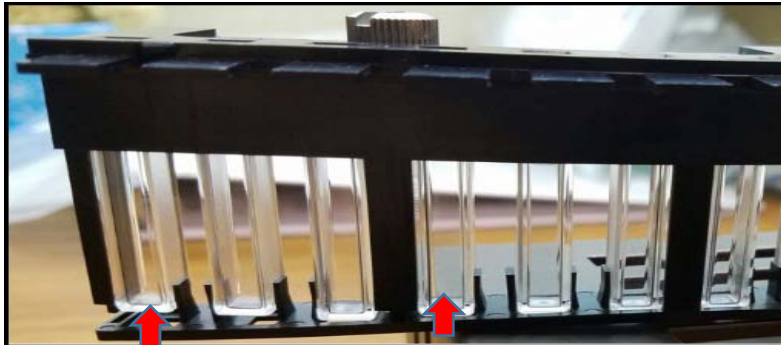
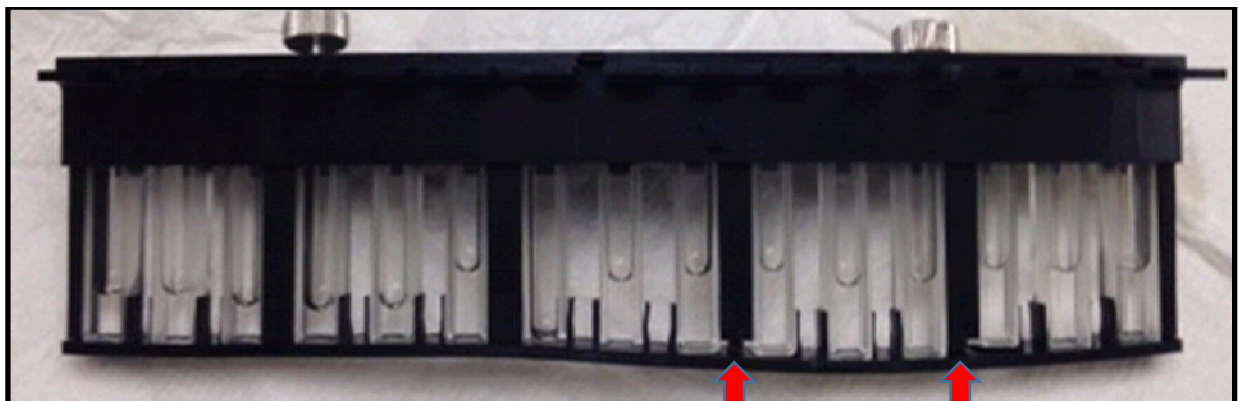
The base of the ARCHITECT Cuvette Segment may become detached under specific conditions. When a cuvette segment base is detached, cuvettes may be seated lower than the designed height. This may result in inadequate dispense into specific cuvettes due to the sample probe being unable to make efficient contact with the cuvette bottom.

The following pictures show examples of cuvette segments where the base is detached from the vertical support post.

*The red arrows indicate where the base has become detached from the vertical support posts*

If a cuvette segment with a detached bottom is identified, replace it before performing any additional testing on your ARCHITECT Clinical Chemistry System.

To remove the cuvette segments from the ARCHITECT for inspection, follow the procedure in ARCHITECT System Operations Manual Section 9 Service and maintenance, Component replacement, Replace a cuvette segment (c4000, c8000, and c16000). Wear gloves, as residual oil from an ungloved hand may cause imprecise optical reads. Once removed from the ARCHITECT, inspect each cuvette segment for damage by gently pulling downwards on the segment base at several points along the segment. If damage is discovered, replace the cuvette segment.
