Field Safety Notice (FSN1 REG-2018-0001-A)

Safety information concerning the sterEOS image review workstation

SUBJECT: Potential error in 3D projections when saving a pair of images after applying a horizontal flip

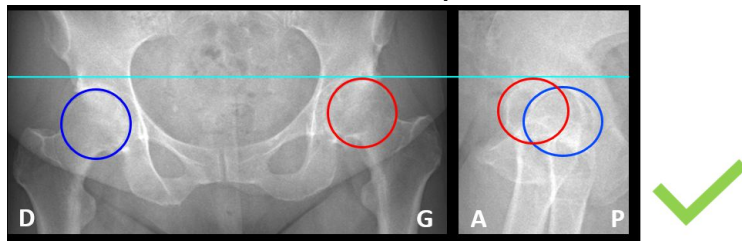
Posteroanterior acquisition

- If the acquisition is indicated as "posteroanterior" on the lateral view, the circle representing the right acetabulum (blue) must be larger than the circle representing the left acetabulum (red).

Users of the 3D sterEOS review workstation are requested to check that 3D projections associated with pelvic parameters match when a 3D image is created from a pair of images belonging to a series of more than two images:

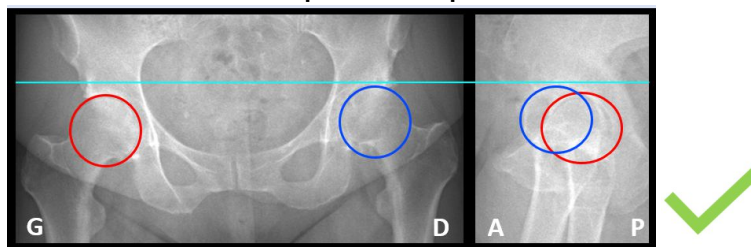
Anteroposterior acquisition

- If the acquisition is indicated as "anteroposterior" on the profile view, the circle representing the right acetabulum (blue) must be smaller than the circle representing the left acetabulum (red).
