Urgent Field Safety Notice

Medtronic DBS Extension Models 37085 and 37086

Reinforcement of Device Labeling

Medtronic reference: FA648

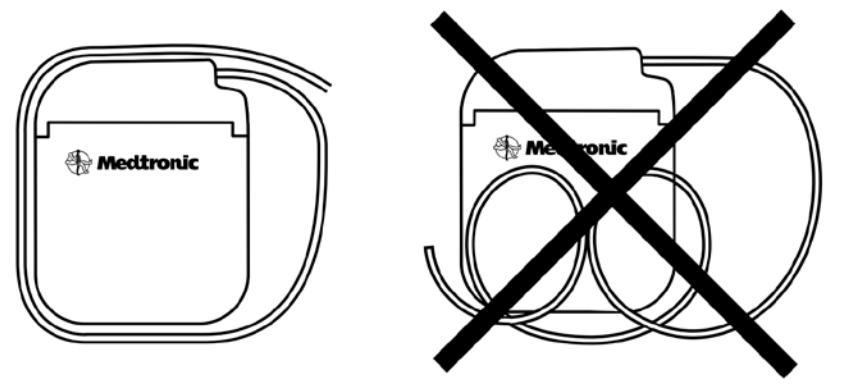
Figure 3. Wrap excess extension around the perimeter of the neurostimulator.

1. Place the neurostimulator into the subcutaneous pocket with the Medtronic logo facing outward, away from muscle tissue, and ensure that the extension is not bent sharply.

- Ensure that the neurostimulator is placed no deeper than 4 cm (1.5 in) below the skin and is parallel to the skin. If the neurostimulator is too deep or is not parallel to the skin, telemetry may be unsuccessful.
- Do not coil excess extension in front of the neurostimulator. Wrap excess extension around the perimeter (Figure 3) of the neurostimulator to minimize subcutaneous pocket depth, help minimize potential damage during neurostimulator replacement surgery, help minimize potential kinking of the extension, and minimize interference with telemetry. Excess extension should not exceed two wraps around the perimeter of the neurostimulator. Extension lengths requiring more than two wraps can interfere with telemetry.
