Urgent Field Safety Notice

Product Name: Patient Labels for Zimmer Products manufactured prior to March 2010

FSCA-identifier: FA-2012-01

Type of Device: Orthopaedic Implants manufactured by Zimmer GmbH, Winterthur (Switzerland) prior to March 2010

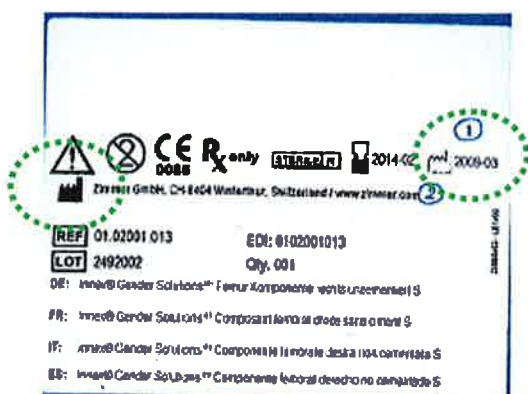
Figure 1, presented below, provides an example of a representative product label which indicates the Zimmer GmbH production site, following the "dark" production plant symbol, and also indicates the production date, following the "white" production plant symbol.

Figure 1: Example of a representative product label providing (1) is the manufacturing date ("white" production plant symbol), and (2) the manufacturing site ("dark" production plant symbol)

In rare cases, product information on the patient label, with respect to REF number/ LOT number might not coincide with the corresponding information on the product label.

While the information printed on the product label is always correct, the information on the patient label (in rare cases) may be wrong. Please note that, although it is unlikely that lots in your consignment delivered to you with manufacturing date prior to March 2010 are affected, we are issuing this letter as preventative information.

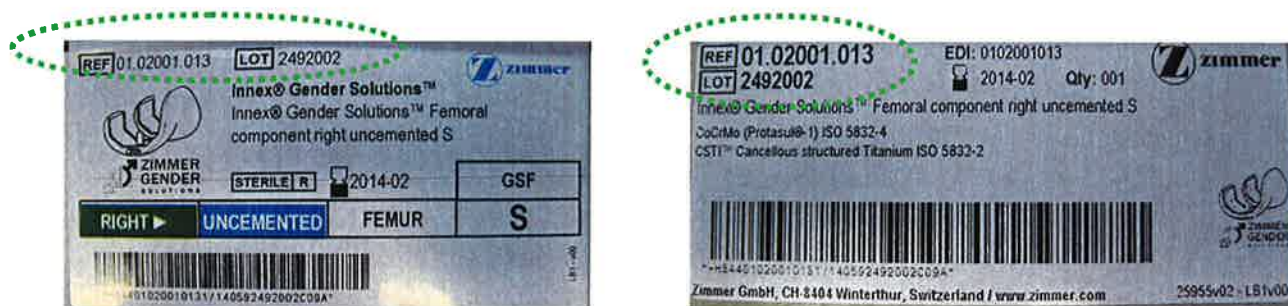
Figure 2: Example of the product label (left) and patient label (right)

Although the identified issue has been corrected at Zimmer GmbH, Winterthur, for products manufactured after March 2010, Zimmer recommends, as a general practice, **to always check the patient label by comparing its information** to the product label at the time of the surgery (please see figure 2).

As stated above, we ask you to **check the patient label by comparing its information** to the product label during the surgery.

However if the patient label should not match with the product label, we kindly ask you to follow these instructions:

- (1) Use whatever your institutional protocol is to **manually** record patient information using the correct information contained on the outer box label;
- (2) **Report** the error to Zimmer.
