Olympus reference: QIL FY24-EMEA-01-FY23-OMTA-13

URGENT FIELD SAFETY NOTICE

Recall of Single Use Distal Cover MAJ-2315

Used with: EVIS EXERA III Duodenovideoscope TJF-Q190V, EVIS LUCERA Elite

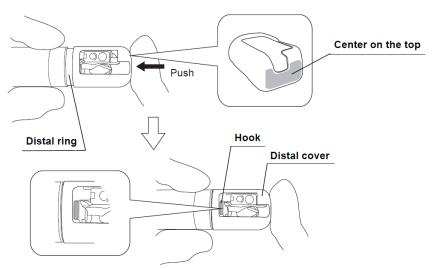
4 Put your finger onto the center on the top of the distal cover and push the top of the distal cover straight onto the distal end of the endoscope until the hook of the distal ring is completely visible within the opening of the distal cover.

WARNING

Detach the distal cover from the distal end of the endoscope when the distal cover cannot be attached to the endoscope smoothly or any incorrect attaching procedure is noticed. Refer to Section 9.5, "Detach the distal cover" for detaching the distal cover. With a new distal cover, repeat Step 1 through 4. If the distal cover is not attached properly, it may slip off or fall off the distal end during the examination. This could result in thermal injury when the endoscope is used with high-frequency EndoTherapy accessories. Also, continuing the examination with the distal cover off may cause patient injury by the uncovered distal end of the endoscope. In addition, if the distal cover falls off in the oral cavity, it may cause aspiration or respiratory distress if not promptly identified and removed.

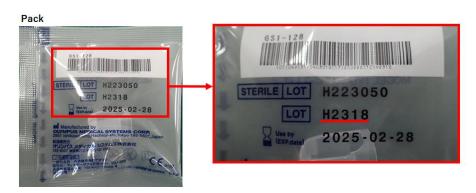
- 1. Carefully read the content of this Field Safety Notice.
- 2. Immediately locate and no longer use the MAJ-2315 with the original design. The original design can be identified by the item code (below) or by lot numbers less than H2530. The image below depicts the area where the lot number is identified. The lot number is on the Carton box and Pack.

Model: MAJ-2315 Item code: N5786100

Lot number:Lower than H2530
