Purpose	This TSB provides directions to verify the installed RAM within BCM SCCs (using Part Number 01L67-003 or 01L67-004) to ensure that they have the required 2 x 2GB RAM chips installed. If needed, this TSB details how to install RAM to bring the SCC to the correct configuration.	System	m2000sp G-Series System
Tools and Materials	<ul style="list-style-type: none"> Standard FSE Tool Kit Anti-static Mat Anti-static Wrist strap 	Estimated Time	Installation: 10 minutes Verification: 5 minutes Total Time: 15 minutes
Parts	<ul style="list-style-type: none"> RAM (BCM) 50-148411 	Distribution	This TSB is for distribution in all areas and internal Abbott Molecular systems.
Implementation	<p>MANDATORY</p> <p>Completion is required and must be recorded for all applicable instruments by:</p> <p>November 30, 2019</p>	Instruments Requiring Modification	Refer to Supplement Document for Bracketing
Instrument TSB Level	The instrument must be at TSB Level <i>TSB 605-065 m2000sp G-Series Release 8.1 Software Install Instructions</i> prior to performing this TSB.

Action	Steps	Reference
Overview	Some BCM SCCs with Part Number 01L67-003 or 01L67-004 have a shortage of RAM. To make sure that every B

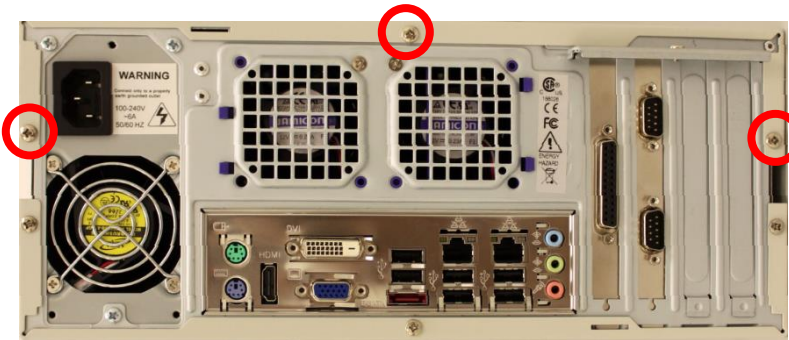
<p>NOTE: If, during this check, you determine the SCC is not a BCM (i.e. does not have part number 01L67-003 or 01L67-004), skip to the Documentation section. Use the General SCC Identification steps in TSB 605-065 if necessary.</p>	
Prepare the Instrument	<ol style="list-style-type: none"> 1. Power off the instrument and SCC Computer. 2. Unplug any peripherals (monitor, printer, modem, etc.) from the SCC. 3. Remove the power cord from the rear of the SCC. 4. Press the power switch on the front of the SCC to discharge any residual static buildup in the SCC. 	N/A
Remove the Computer Cover	<ol style="list-style-type: none"> 1. Remove the three screws securing the cover to the computer.

<ol style="list-style-type: none"> 2. Slide the cover back then lift to remove. 3. Place the cover to one side to create an area to place the components that will be removed and reused in the procedure. 	N/A

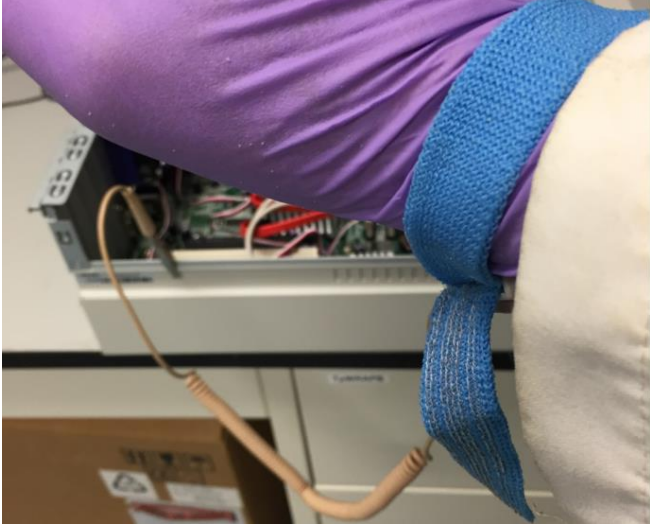
Preparing for RAM Installation	<p>IMPORTANT: Use a grounded wrist strap when handling components to avoid damaging them due to static electricity.</p> <ol style="list-style-type: none"> 1. Attach the ground strap to <i>the wrist of the hand</i> that you will use to handle/touch the memory modules. 	N/A

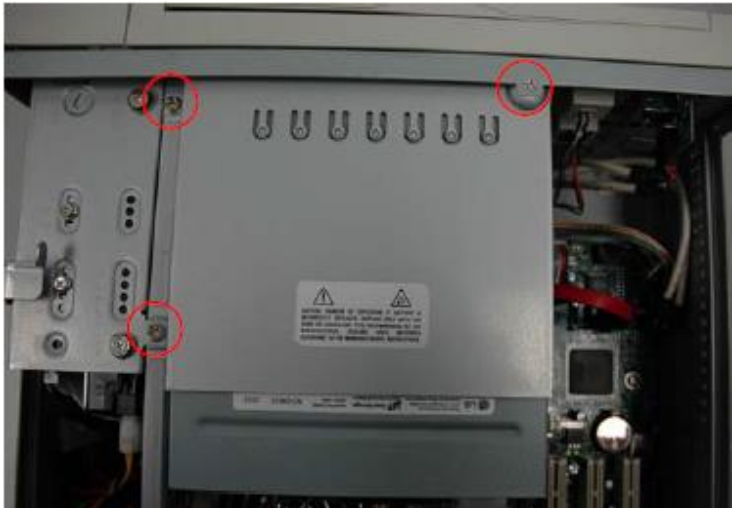
<p>2. Follow these guidelines to avoid damaging components:</p> <ul style="list-style-type: none"> • Always hold components by the edges to avoid touching the ICs. • Whenever you uninstall any component, place it on a grounded antistatic pad or in the bag that came with the component. • Before you install or remove any component, ensure that the ATX power supply is switched off and the power cord is removed from the power supply. Failure to do so may cause severe damage to the motherboard, peripherals, and/or components. 	
Install New RAM	<p>1. Remove the three screws securing the Optical Drive. Do not disconnect any cables. Lift the drive out of the way to gain access to the memory modules.</p>

<p>2. Unlatch the locking lever on each side of the existing memory modules.</p> <p>NOTE: If 2 x 2GB RAM chips appear to be installed already, you may wish to reseat them, reassemble the SCC, and re-perform the check to verify the SCC has 4.0GB of RAM. If the check still shows the RAM is insufficient, troubleshoot further and replace the memory modules.</p>	N/A

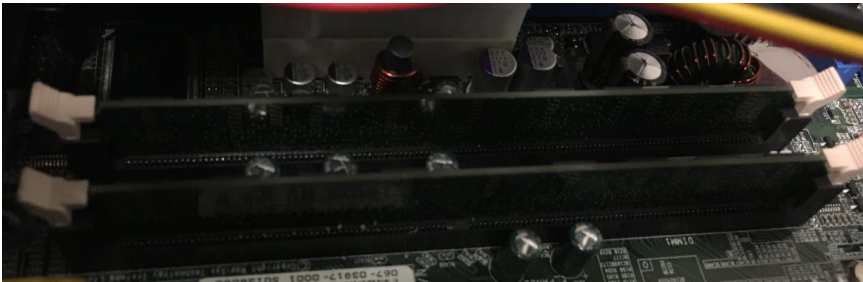
Action	Steps	Reference
	<p>3. Remove the two existing modules.</p>

<p>4. Install the TWO new memory modules into the specified slots. Be sure that each module seats firmly into the slot and that the locking tabs secure the module in place.</p>	
Instrument Preparation and Verification	<ol style="list-style-type: none">1. Re-install the optical drive.2. Install the SCC cover.3. Plug in all instrument peripherals (monitor, printer, etc.)4. Refer to Inspect the Instrument at Customer Site section to verify that 4 GB of RAM is installed.	N/A

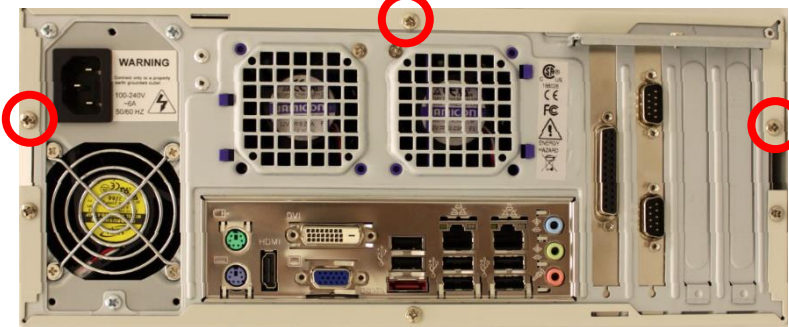
<p>NOTE: If, during this check, you determine the SCC is not a BCM (i.e. does not have part number 01L67-003 or 01L67-004), skip to the Documentation section. Use the General SCC Identification steps in TSB 610-051 or TSB 610-052 if necessary to identify the SCC.</p>	
<p>Prepare the Instrument</p>	<ol style="list-style-type: none"> 1. Power off the instrument and SCC Computer. 2. Unplug any peripherals (monitor, printer, modem, etc.) from the SCC. 3. Remove the power cord from the rear of the SCC. 4. Press the power switch on the front of the SCC to discharge any residual static buildup in the SCC. 	N/A
<p>Remove the Computer Cover</p>	<ol style="list-style-type: none"> 1. Remove the three screws securing the cover to the computer.

<ol style="list-style-type: none"> 2. Slide the cover back then lift to remove. 3. Place the cover to one side to create an area to place the components that will be removed and reused in the procedure. 	N/A

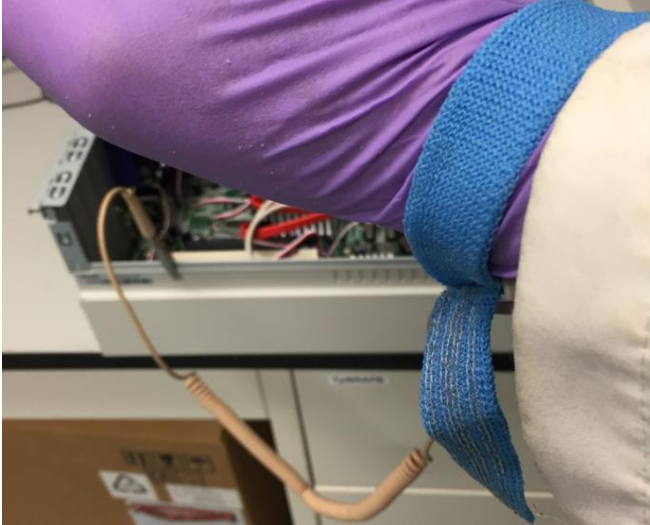
Action	Steps	Reference
Preparing for RAM Installation	<p>IMPORTANT: Use a grounded wrist strap when handling components to avoid damaging them due to static electricity.</p> <ol style="list-style-type: none"> 1. Attach the ground strap to <i>the wrist of the hand</i> that you will use to handle/touch the memory modules.

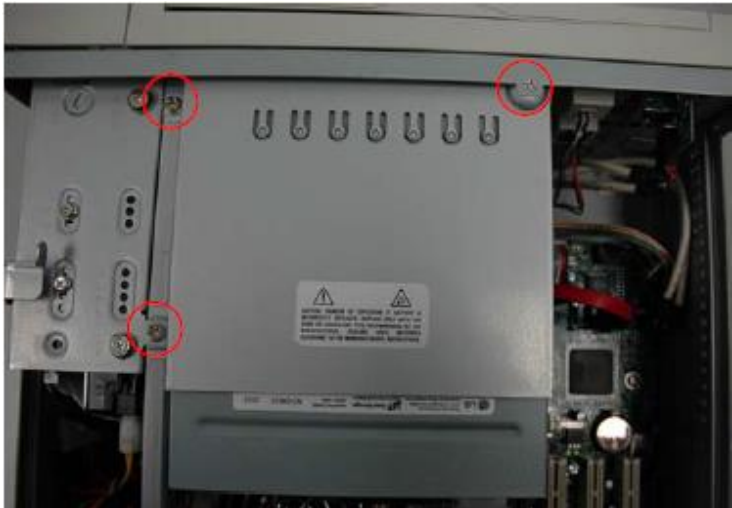
<ol style="list-style-type: none"> 2. Follow these guidelines to avoid damaging components: <ul style="list-style-type: none"> • Always hold components by the edges to avoid touching the ICs. • Whenever you uninstall any component, place it on a grounded antistatic pad or in the bag that came with the component. • Before you install or remove any component, ensure that the ATX power supply is switched off and the power cord is removed from the power supply. Failure to do so may cause severe damage to the motherboard, peripherals, and/or components. 	N/A
Install New RAM	<ol style="list-style-type: none"> 1. Remove the three screws securing the Optical Drive. Do not disconnect any cables. Lift the drive out of the way to gain access to the memory modules.

Action	Steps	Reference
	<p>2. Unlatch the locking lever on each side of the existing memory modules.</p> <p>NOTE: If 2 x 2GB RAM chips appear to be installed already, you may wish to reseat them, reassemble the SCC, and re-perform the check to verify the SCC has 4.0GB of RAM. If the check still shows the RAM is insufficient, troubleshoot further and replace the memory modules.</p> <p>3. Remove the two existing modules.</p>

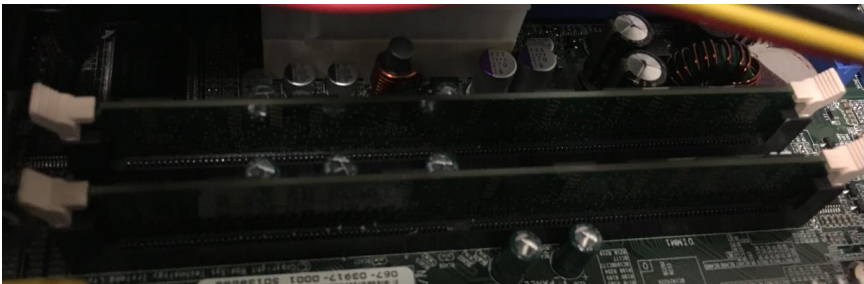
<p>4. Install the TWO new memory modules into the specified slots. Be sure that each module seats firmly into the slot and that the locking tabs secure the module in place.</p>	
Instrument Preparation and Verification	<ol style="list-style-type: none"> 1. Re-install the optical drive. 2. Install the SCC cover. 3. Plug in all instrument peripherals (monitor, printer, etc.) 4. Refer to Inspect the Instrument at Customer Site section to verify that 4 GB of RAM is installed. 	N/A

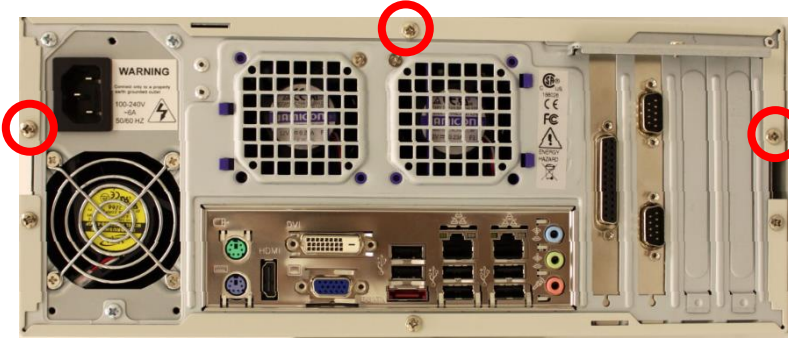
<p>NOTE: If, during this check, you determine the SCC is not a BCM (i.e. does not have part number 01L67-003 or 01L67-004), skip to the Documentation section. Use the General SCC Identification steps in TSB 606-057 if necessary to identify the SCC.</p>	
Prepare the Instrument	<ol style="list-style-type: none"> 1. Power off the instrument and SCC Computer. 2. Unplug any peripherals (monitor, printer, modem, etc.) from the SCC. 3. Remove the power cord from the rear of the SCC. 4. Press the power switch on the front of the SCC to discharge any residual static buildup in the SCC. 	N/A
Remove the Computer Cover	<ol style="list-style-type: none"> 1. Remove the three screws securing the cover to the computer.

<ol style="list-style-type: none"> 2. Slide the cover back then lift to remove. 3. Place the cover to one side to create an area to place the components that will be removed and reused in the procedure. 	N/A

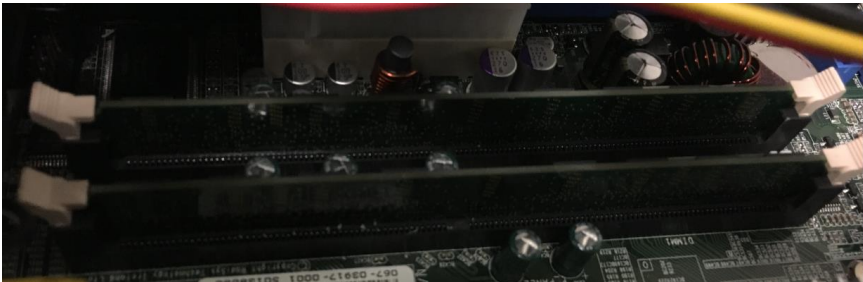
Action	Steps	Reference
	<p>3. Remove the two existing modules.</p>

<p>4. Install the TWO new memory modules into the specified slots. Be sure that each module seats firmly into the slot and that the locking tabs secure the module in place.</p>	
Instrument Preparation and Verification	<ol style="list-style-type: none">1. Re-install the optical drive.2. Install the SCC cover.3. Plug in all instrument peripherals (monitor, printer, etc.)4. Refer to Inspect the Instrument at Customer Site section to verify that 4 GB of RAM is installed.	N/A
