URGENT FIELD SAFETY NOTICE

**Edwards Lifesciences LLC
Ascendra 2 Delivery System – Loader Assembly
Model Numbers 9320AS23 and 9320AS26**

Ref: AT-GEN-0000039

January 07, 2011

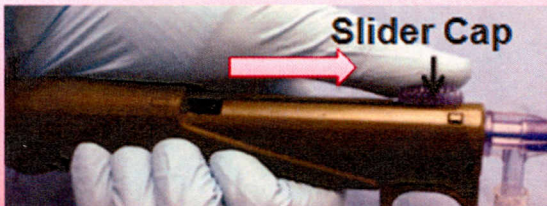
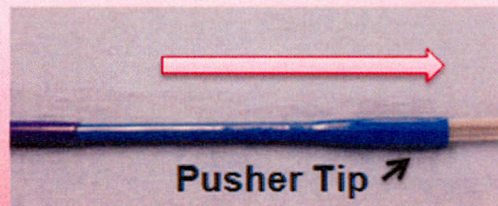
7. Slide delivery system into loader

- Advance slider cap distally and lock so pusher tip prevents kinking of balloon

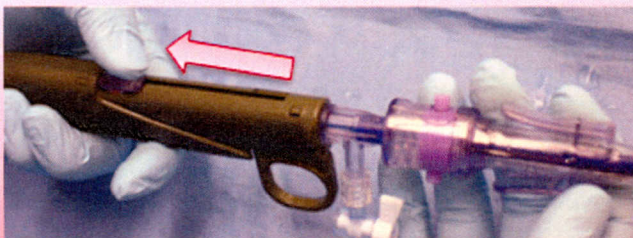
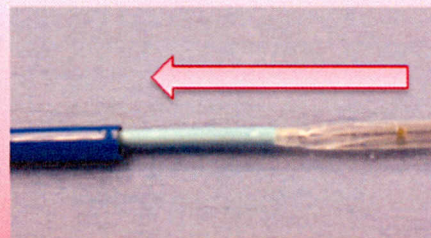
- Retract slider cap proximally and lock so pusher tip moves back to packaged position

- Following the instructions for use, flush the loader from the distal hub of the delivery system. If the button valves on the loader have become partially dislodged, fluid will be seen leaking from around one or both of the button valves. If this happens press both button valves several times to reseat the seal and then repeat the flushing procedure as per the instructions for use.

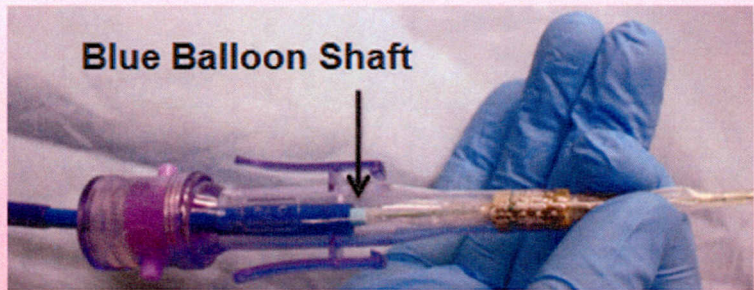
- Retract slider cap proximally to the edge of the blue balloon shaft so that the pusher tip sits off of the balloon

If fluid appears to be leaking from the button valves, press both button valves a few times to re-align the button valve seal to the loader and **reflush** again according to the steps above.
