URGENT - Medical Device Correction Philips HeartStart MRx Defibrillator/Monitor RFU Indicator shows undocumented pattern

<p>AFFECTED PRODUCTS</p>	<p>Product: Philips HeartStart MRx Defibrillator/Monitor</p> <p>Units Affected: MRx unit types with software versions F.03.06 (M3535A) and T.00.05 (M3536A) and earlier and the following part numbers:</p>

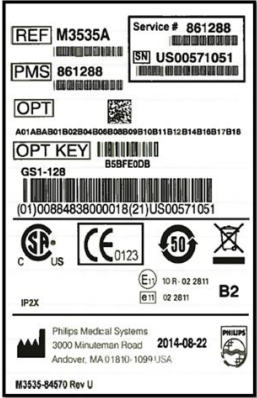
<p>Note that while an MRx experiencing this issue will reliably report this code in the Status Log, existence of the C000A4 code in the Status Log does not necessarily mean that the device is experiencing this issue.</p>
<p>HAZARD INVOLVED</p>	<p>If the issue were to occur the user may unnecessarily remove the MRx from service. However, the performance of the device in use is unaffected by this issue.</p>
<p>HOW TO IDENTIFY AFFECTED PRODUCTS</p>	<p>Philips HeartStart MRx Defibrillator/Monitors identified in the Affected Products section above are affected by this issue.</p> <p>The part number of the HeartStart MRx Defibrillator/Monitor is printed on the primary label on the bottom of the MRx</p>
