Ceiling hoist Product-information/change GH3 Trolley

Product-information No. 01-417
Skejby, Date 13.02.2012

GH3 Trolley guide No. 550097

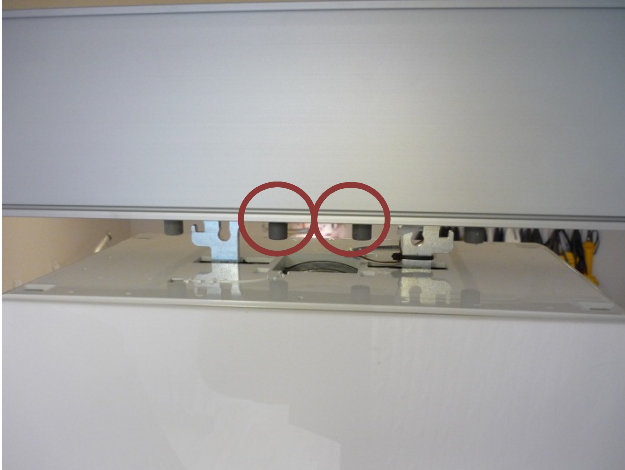
1)

Use a piece of paper to insert between the two trolleys to prevent the trolley guides from falling into the hoist when you remove the two inner trolley guides.
