## To our customers of disposable breathing circuits/-sets

### Important Safety Notice!!!

#### Possible hose short circuit

**Only disposable breathing circuits on the attached list are affected**

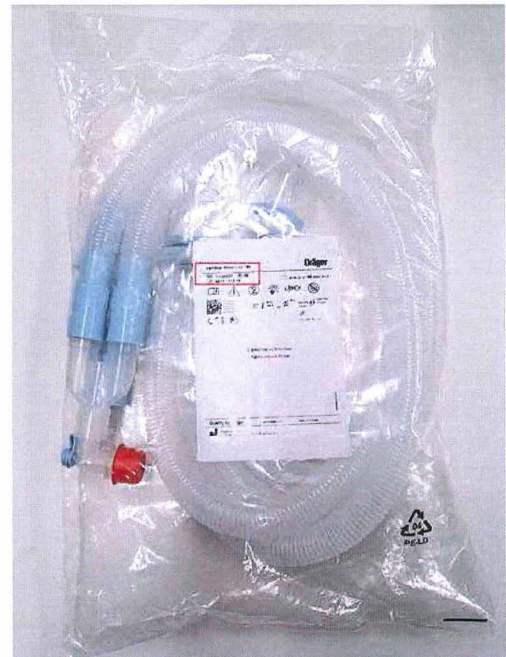
position of material number

According to our records, it is possible that breathing circuits that may be affected, i.e. that may have been incorrectly pre-assembled, were shipped to you during the past two years. We attach a list of material numbers that may be affected. The material numbers of the breathing circuits can be found on the respective packaging (see photo).

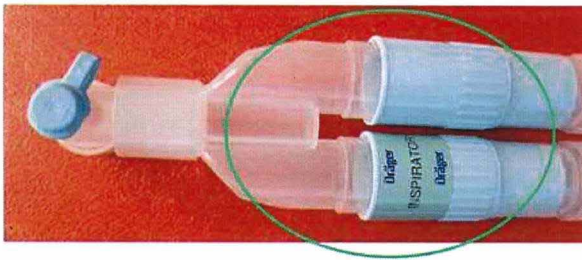
ok

Images showing correct "open ends" and incorrect "open ends" (test instructions):

**Part Numbers:** MP00337, MP00372, MP02720, MP02721, MP00334, MP00361, MP00362, MP00371, MP00374, MP00375, MP01682.

**Before each use, and also after any temporary disconnection, please make sure to check whether the breathing circuit is assembled such that both the inspiratory and the expiratory connector of the ventilator or anesthesia machine are each connected to the y-piece.**

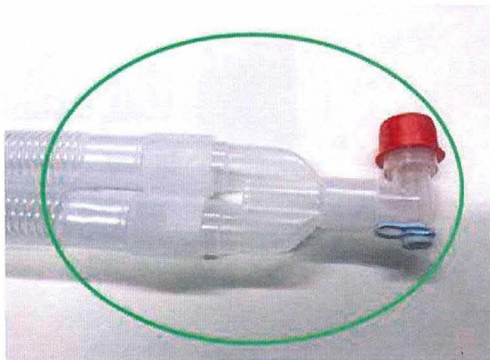
ok

**Part Numbers:** MP00349, MP00350, MP00351, MP00352, MP01326, MP01340, MP01341, MP01348, MP01350, MP00365, MP00366, MP01656, MP01657, MP01674, MP07955, MP07956, MP07981, MP07988, MP07989, MP07991, MP07992, MP07994.
